LAKE CHOCTAW DAM

NDS ID NO. PA-00819

PHASE I INSPECTION REPORT

NATIONAL DAM INSPECTION PROGRAM

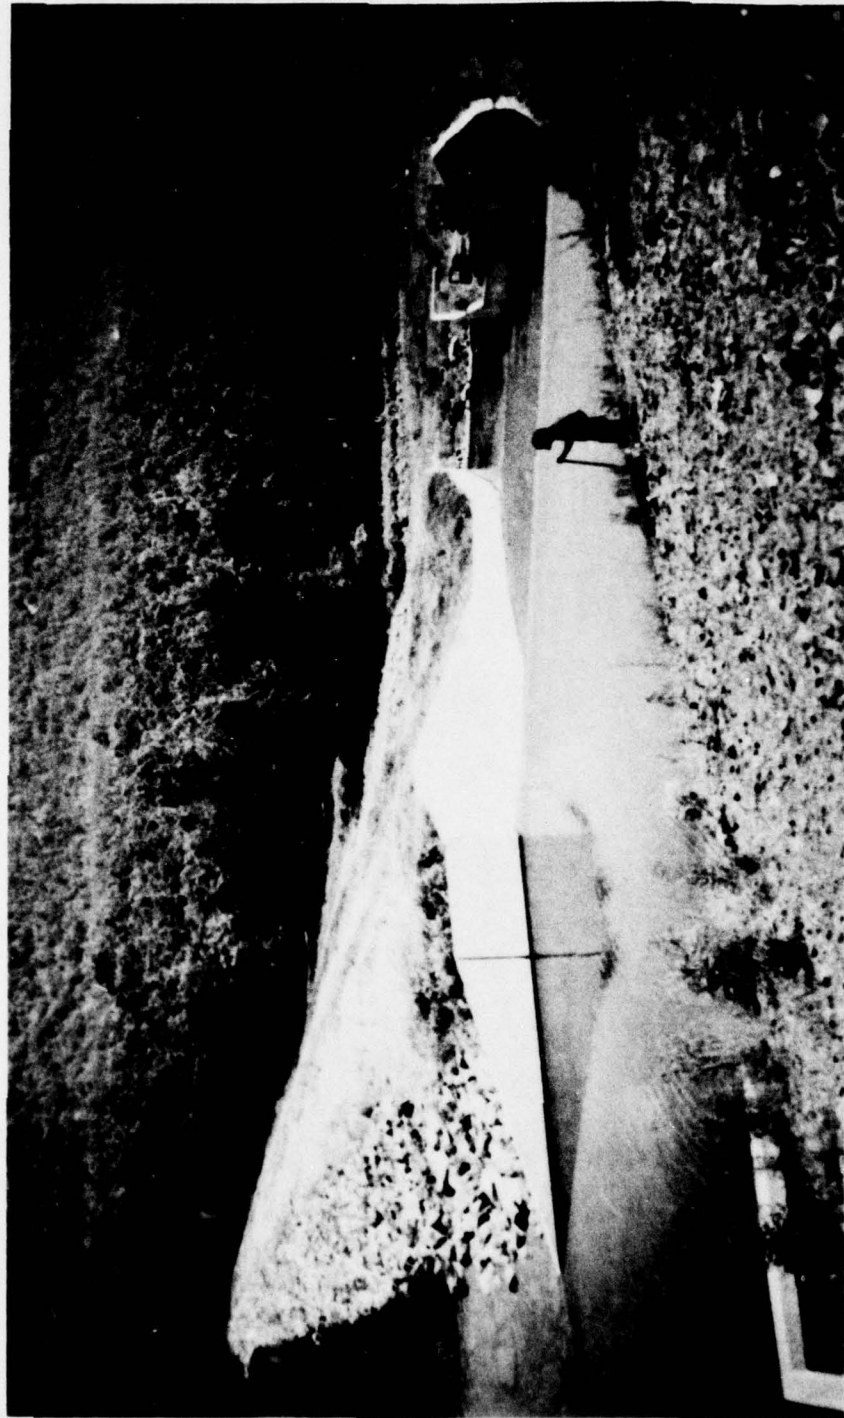
Embankment and Spillway

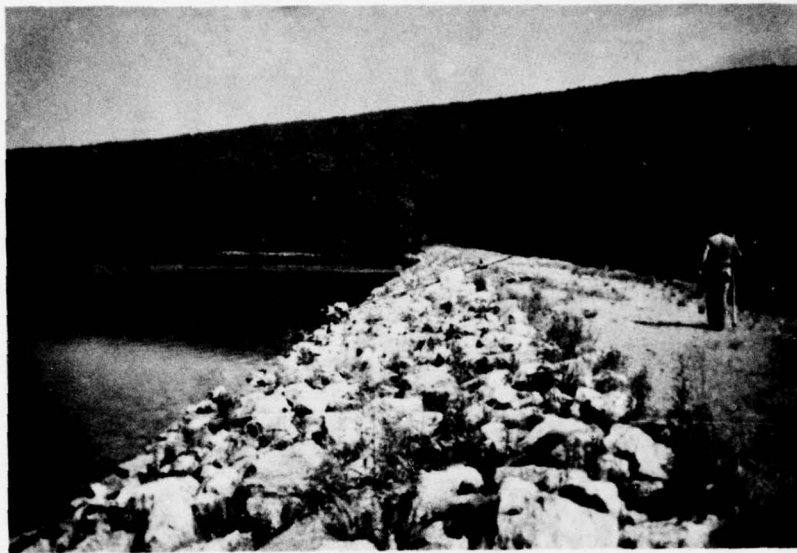
A. Upstream Slope of Embankment.

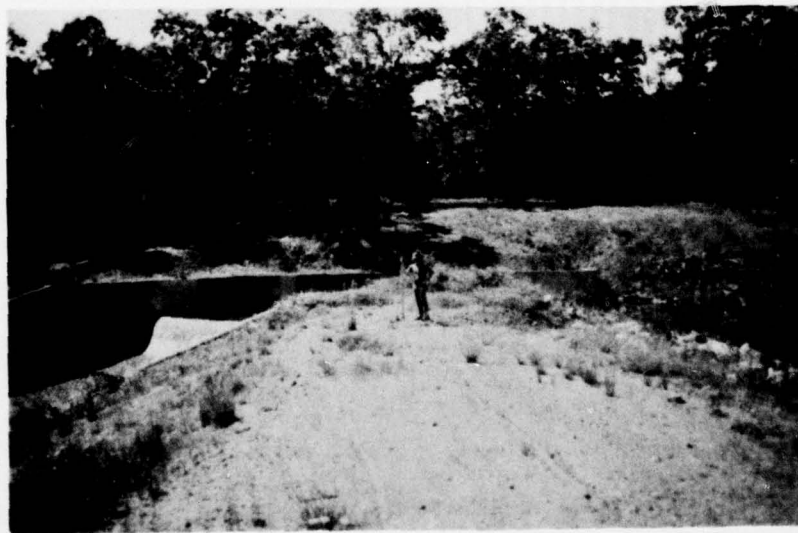
B. Low Area on Embankment Near Spillway.

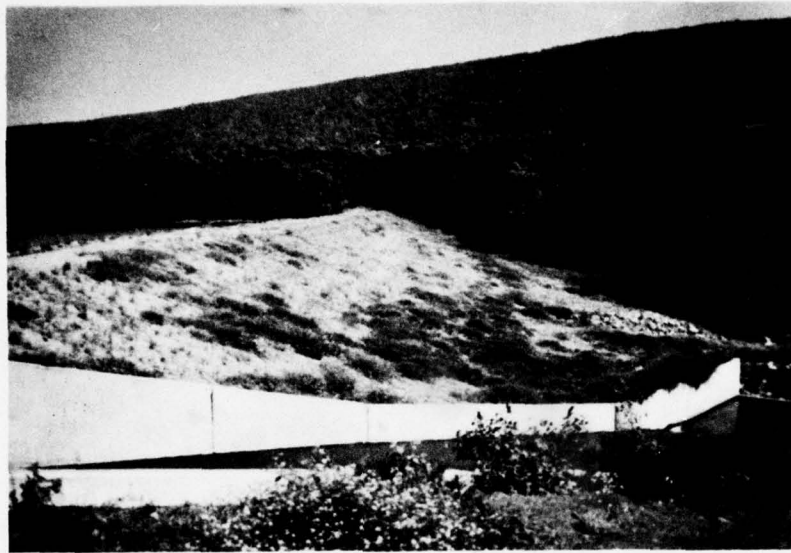
C. Downstream Slope of Embankment with  
Spillway Chute in Foreground.

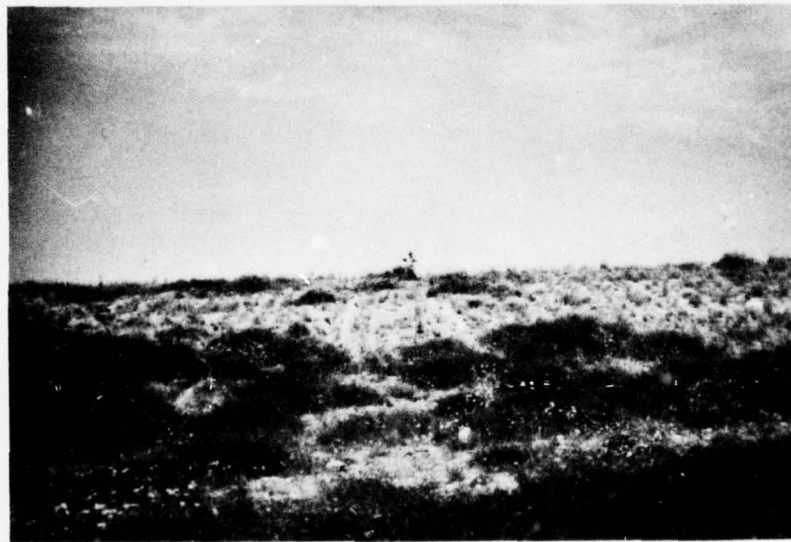
(2) Surveys made for this inspection also indicated that the downstream slope of the embankment might be slightly steeper than the design slope. As measured, the slope at two sections was found to be about 1V on 2.6H, which is steeper than the 1V on 3H shown on the plans. The upstream slope could not be determined because most of it was submerged.

D. Downstream Slope of Embankment.

(4) Until good vegetal cover is established on the downstream slope, the Owner should monitor the condition of the embankment and promptly fill any erosion gullies that might develop.

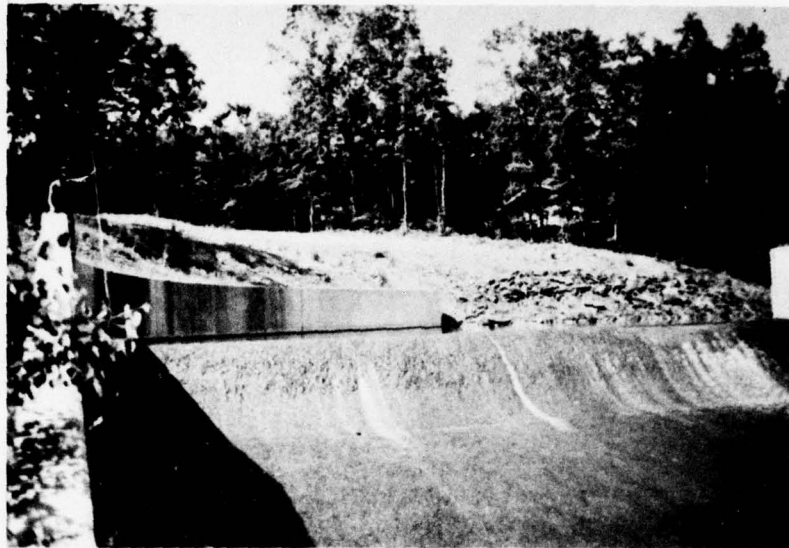
(1) Spillway. A heavy growth of algae covered all the concrete surfaces that had water flowing over them (Photographs E and F). Some of the algae was scraped away, and the concrete appeared to be in good condition. All other exposed concrete was in excellent condition and had no cracks, spalls, or other defects.

(1) The algae growth in the spillway is undesirable because it hinders inspection and would mask the development of any adverse conditions.

E. Spillway Approach Channel and Weir.

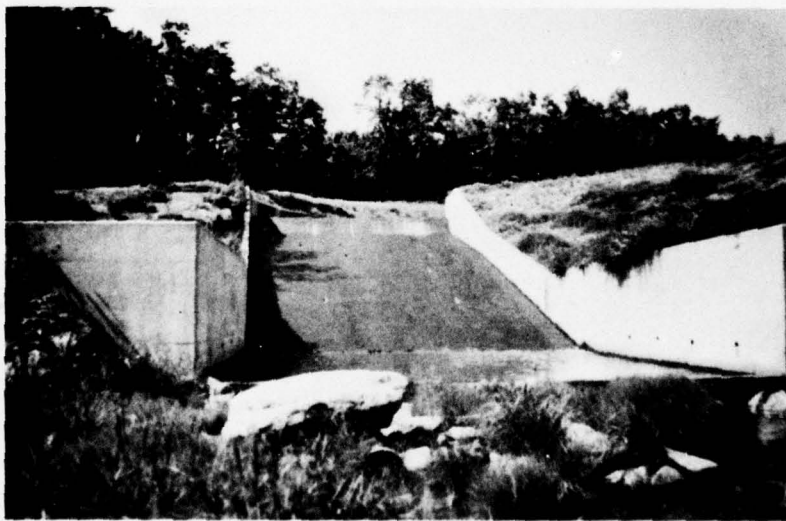
F. Spillway Chute and Stilling Basin.

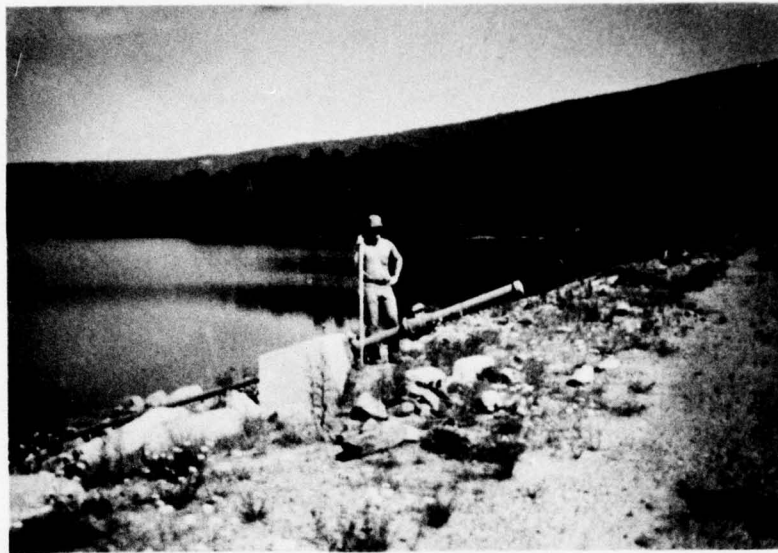
(2) Outlet Works. The gate stand at the top of the embankment was in good condition (Photograph G). Neither the conduit nor the outlet structure had any deficiencies (Photograph H). A toe drain outlet is located on each sidewall of the outlet structure. Neither outlet had any flow. During the inspection, the slide gate was opened easily to about 1/3 full opening (Photograph G). After closing the gate, it sealed tightly with no significant leakage. The Owner said that the gate is partially opened every six months, and, at the same time, the oil level in the stem casing is checked to insure that it is kept full. The outlet channel is riprapped from the outlet structure to the spillway outlet channel. Some minor gaps were visible in the riprap, but there was no apparent erosion.

G. Gate Stand on Top of Dam.

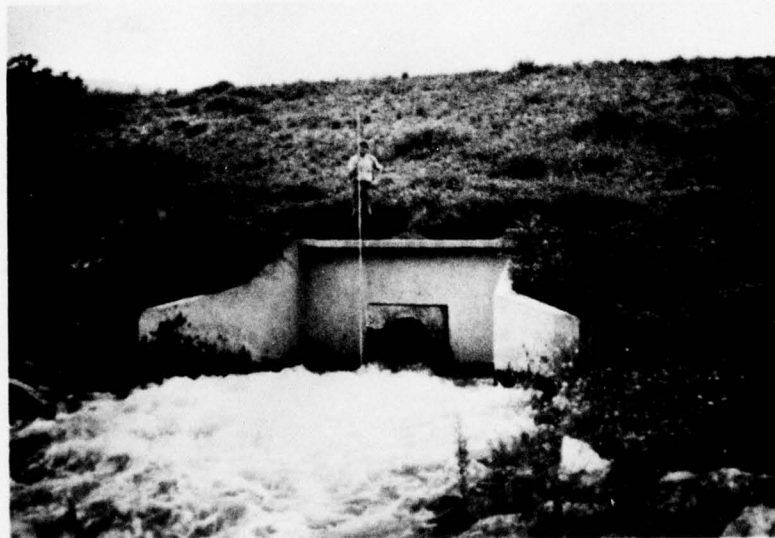
(2) Nothing was observed in the outlet works that raised any concern for the condition of the dam.

H. Outlet Works During Operation of Slide Gate.

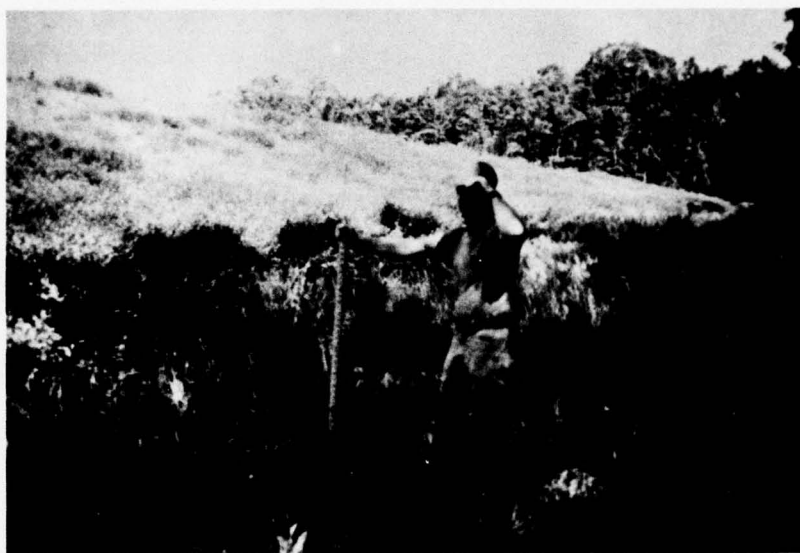
(5) A wet area was located along the downstream toe of the embankment about 200 feet from the left abutment (Photograph J). A slight amount of standing water was visible, but no flow was observed. The area was not particularly soft, and it appeared that the probable source was surface runoff.

(5) The two wet areas along the downstream toe of the embankment appear to be the result of surface runoff. However, the wet areas are in the vicinity where Northeastern Engineering Company encountered springs during the investigation of the site. If springs should develop, the stability of the embankment could be affected. Consequently, any unusual conditions along the toe in this area are of general concern.

J. Wet Area at Toe of Embankment  
200 Feet from Left Abutment.

(5) Visually monitor the two wet areas along the downstream toe of the dam. The outflow should be estimated and records should be kept so that any change in condition is apparent.

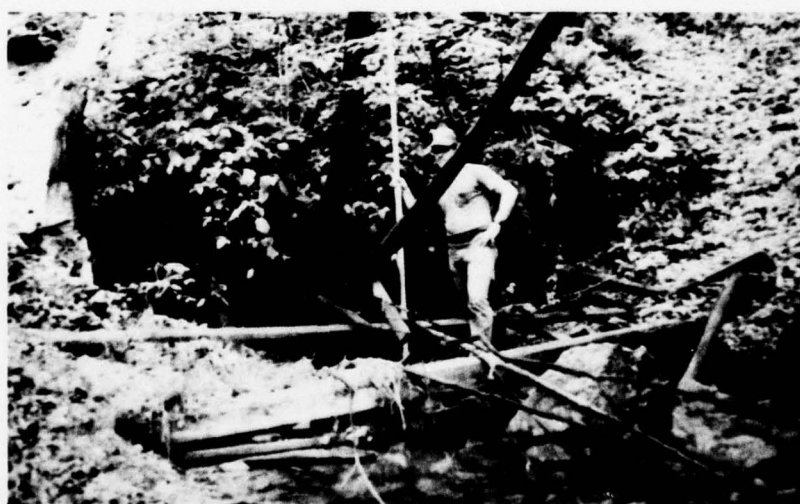
c. Reservoir Area. The existence of a source of acid inflow into the reservoir is undesirable. Although there were no signs of concrete deterioration during the inspection, long periods of low flow could cause the acid condition to worsen and possibly cause concrete deterioration. As far as could be determined from interviews with the Owner and other available information, the quantity of flow from the mine tunnel does not vary greatly, and, therefore, is of little consequence hydrologically. The existence of Lake Susquehanna Dam upstream from Lake Choctaw Dam does have significant effects on Lake Choctaw Dam. These effects are discussed in Section 5 of this report.

K. Mine Tunnel Opening on Left Hillside  
0.4 Mile Upstream.
